**ARCHEOLOGICAL AND HISTORIC RESOURCES
SURVEY OF TWO PROPOSED PAVILION LOCATIONS
AT APACHE PARK IN SAN ANTONIO
BEXAR COUNTY, TEXAS**

**Prepared for
City of San Antonio, Texas**

**Prepared by
URS Corporation**

May 2009

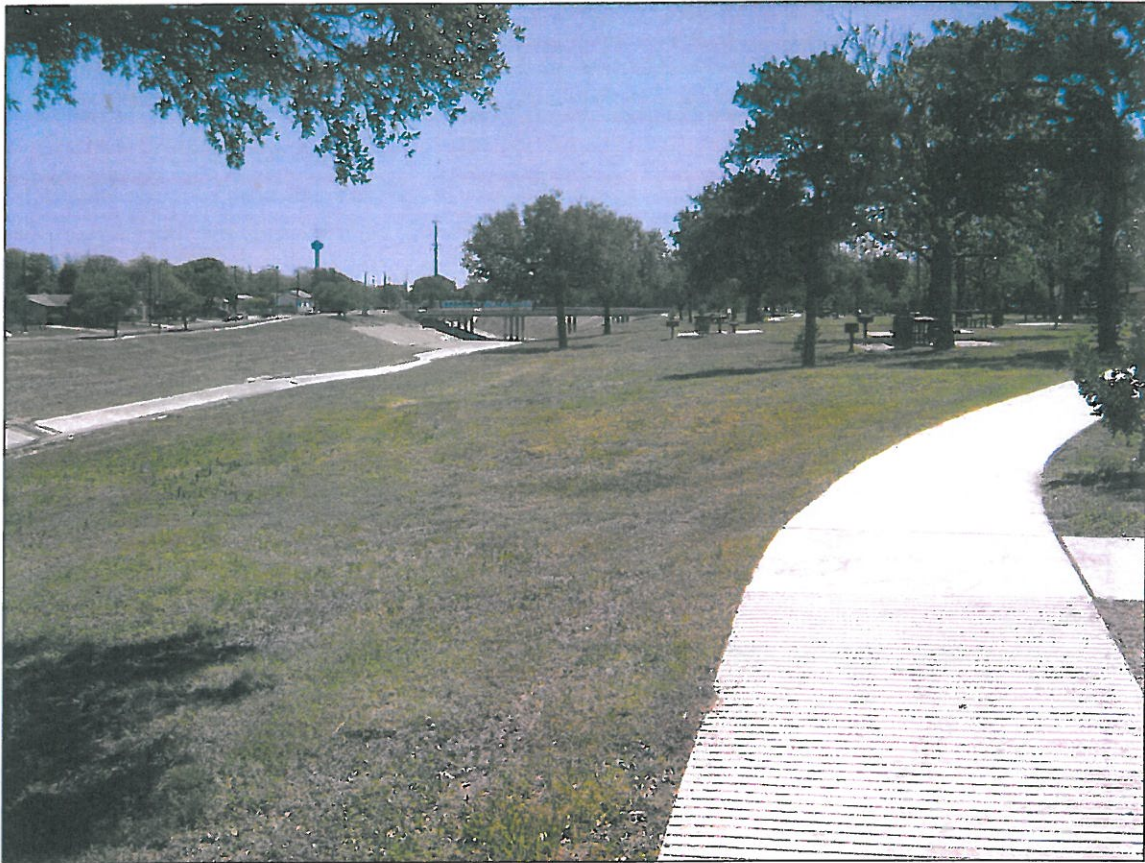
The project area is located in a residential neighborhood in central San Antonio in Bexar County, Texas (Figure 1). The city-owned park is between Apache Creek to the north, and South Laredo Street on the south. The park and surrounding area is characterized by well-maintained open grasses, with a few scattered oak trees. The built environment at the park consists of a parking area, with several cement slabs and picnic tables to the west of the parking area (Figure 2).

Figure 2. Overview of Apache Park, facing east.

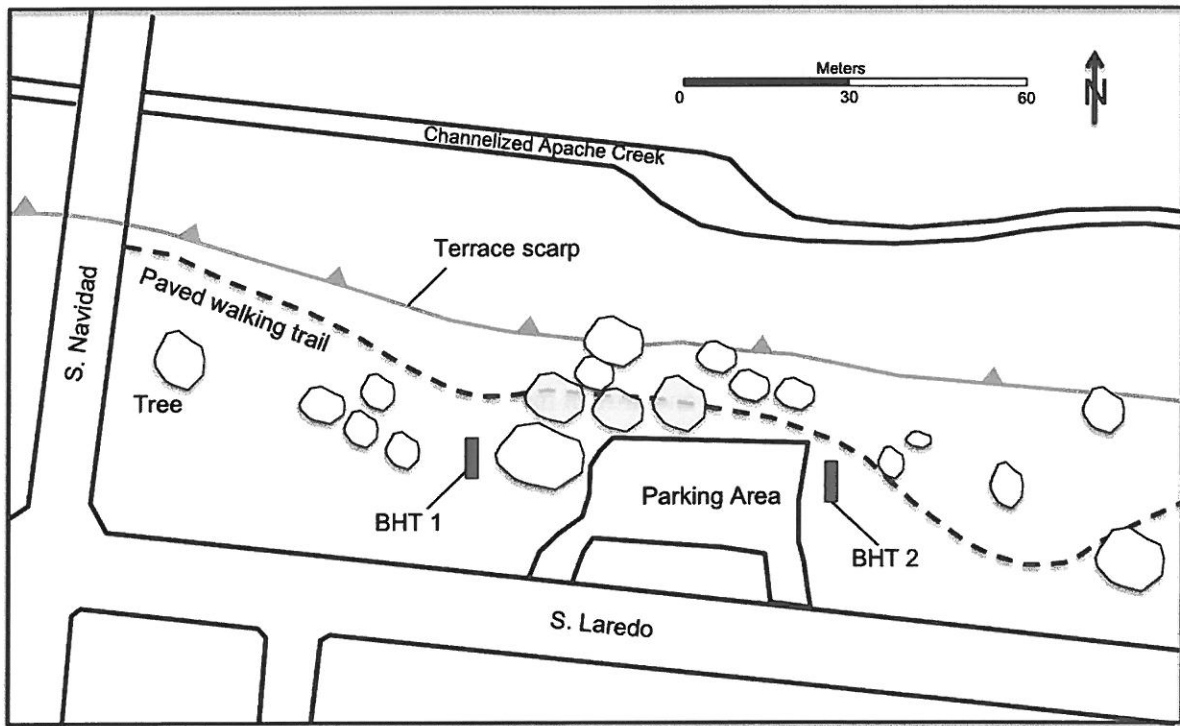
Figure 3. Site map of APE with backhoe trench locations.

- One backhoe trench was excavated in each of the two proposed pavilion location. Each trench measured approximately 4 meters in length, 1 meter wide, and from 1.3 to 2.0 meters deep. One wall in each trench was selected for detailed soil descriptions following standard NRCS procedure (Soil Survey Division Staff, 1993). Trenches were photographed and then backfilled to the original topography.

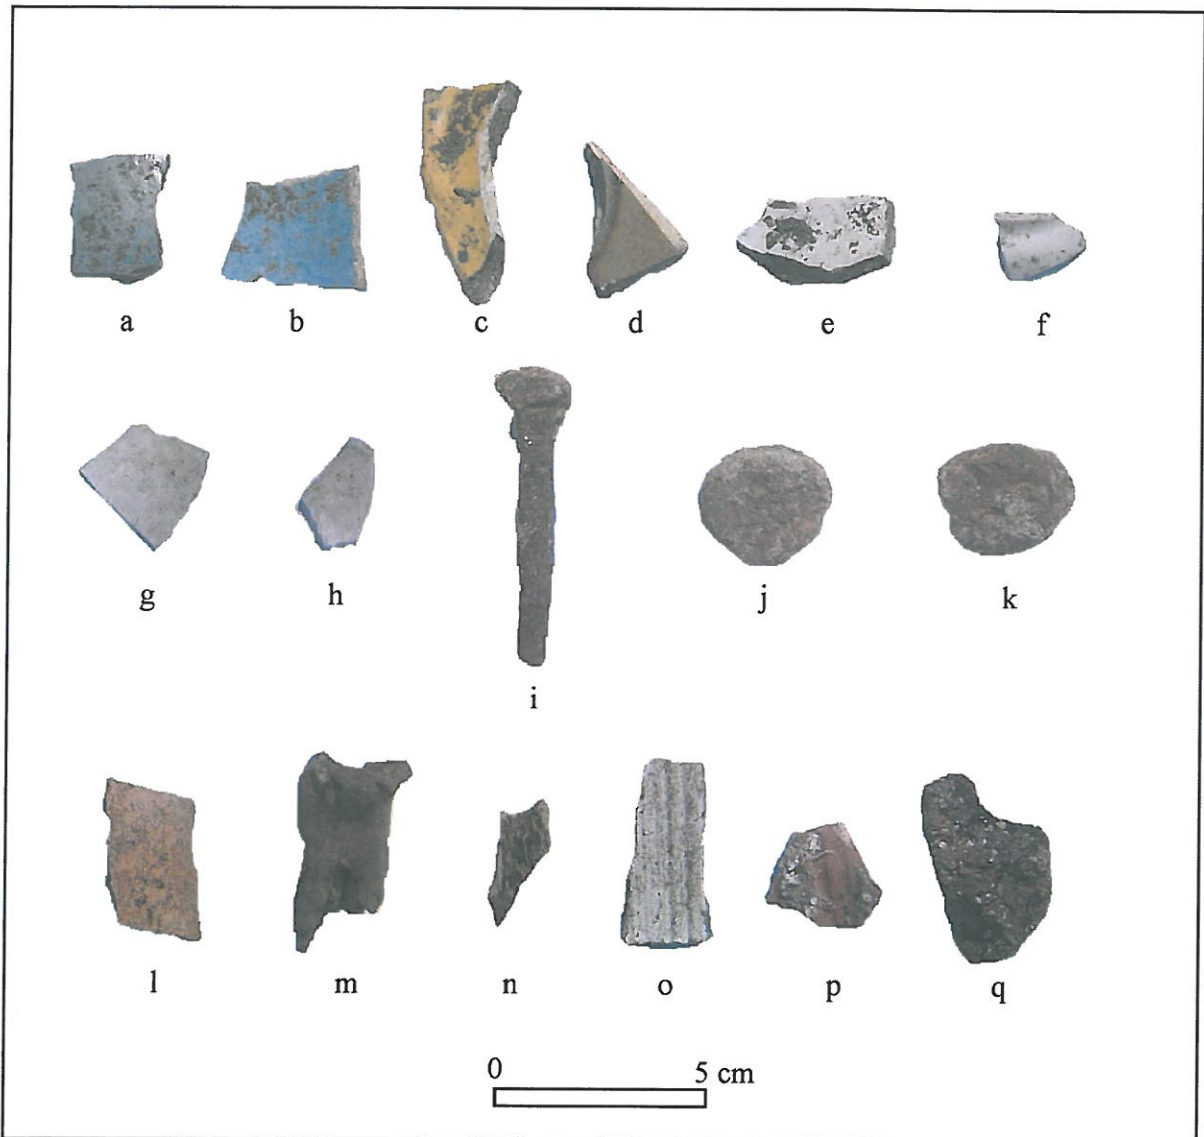
The identified historic artifacts were found mixed with fill debris that appears to have been emplaced upon the original terrace surface, presumably during construction of the park. A summary of observed artifacts are listed in Table 1, and a representative sample is illustrated in Figure 4.

Figure 4. Selected artifacts from fill deposit in APE: a-b) blue-glazed ceramic sherd; c) yellow glazed rim fragment; d) crookery fragment; e) whiteware; f) porcelain; g) flat glass; h) clear glass; i) rusted wire nail; j-k) rusted bottle caps; l) flat bone; m) proximal end of medium mammal long bone; n) unidentified bone; o-p) ceramic roofing tile; q) fragment of tar shingle.

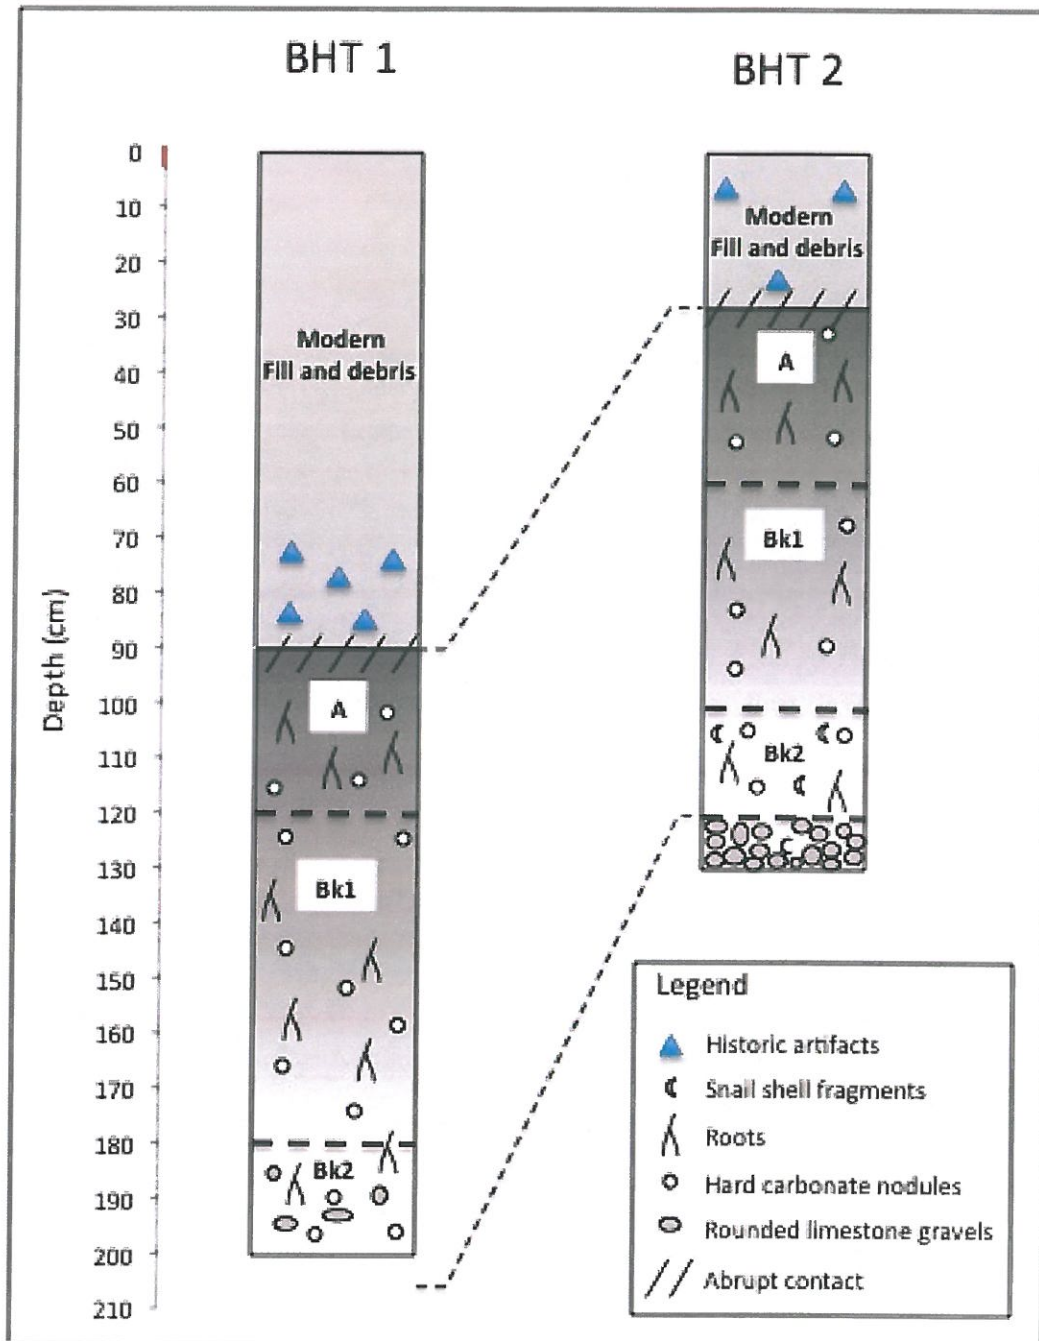
Backhoe trench profiles are provided in Figure 5. Backhoe trench (BHT) #1 was situated on the west side of the parking area and was excavated to 2.0 meters below surface. Detailed profile examination revealed a 90 cm-thick deposit of poorly sorted and coarse, gravelly, debris-filled material overlying an undisturbed clayey A-Bk1-Bk2 horizon sequence (90-200 cm), which was developed on the original Apache Creek terrace (Figure 6). Soil descriptions were consistent for those mapped for the Lewisville silty clay loam soil mapping unit. Evidence of roots and calcium carbonate nodules was found throughout the soil profile. A few water-rounded gravels were noted in the Bk2 horizon (180-200 cm), indicating that ancient (Pleistocene) channel gravels were probably not much deeper. No cultural materials were found within the native soil profile; all identified historic artifacts were contained within the disturbed fill material. Based on the profile assessment, it does not appear that

the original soil profile has been disturbed; rather, the fill was emplaced directly on the terrace surface.

Figure 5. Trench profiles recorded within APE.

BHT #2 was situated on the east side of the parking area and was excavated to 1.3 meters below surface (see Figure 5). Fill deposits at this location were 27 cm thick and overlie the same soil surface and horizon sequence as described for BHT 1 (Figure 7). Fewer historic artifacts were found in this trench, but were still confined to the fill deposits. No cultural materials were found within the native soil profile. Based on the profile assessment, it does not appear that the original soil profile has been disturbed; rather the fill, albeit shallower, was emplaced directly on the terrace surface.

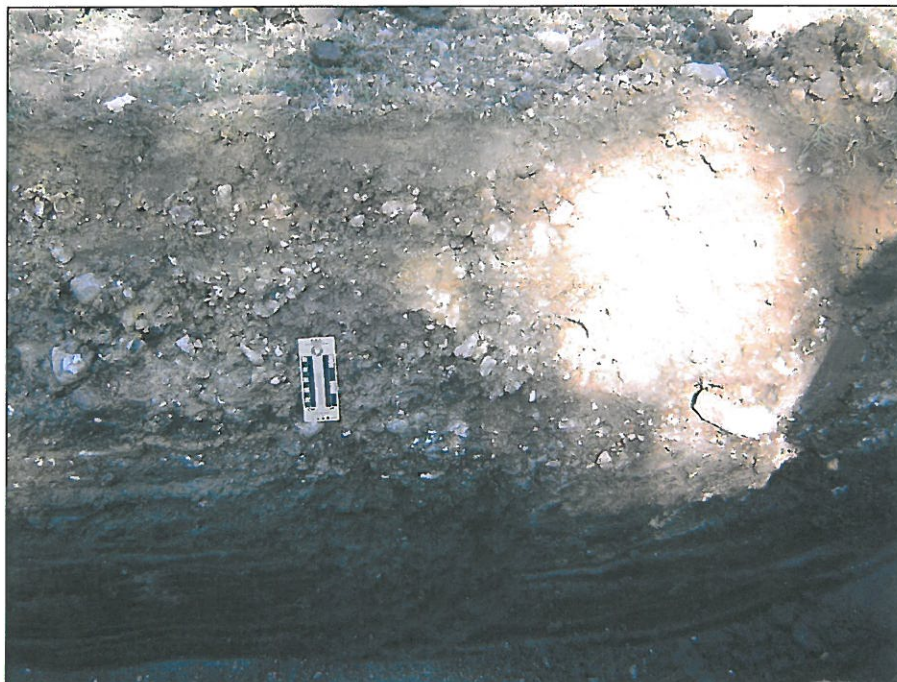
Figure 6. West wall profile of BHT 1 illustrating thick fill/debris in upper 90 cm.

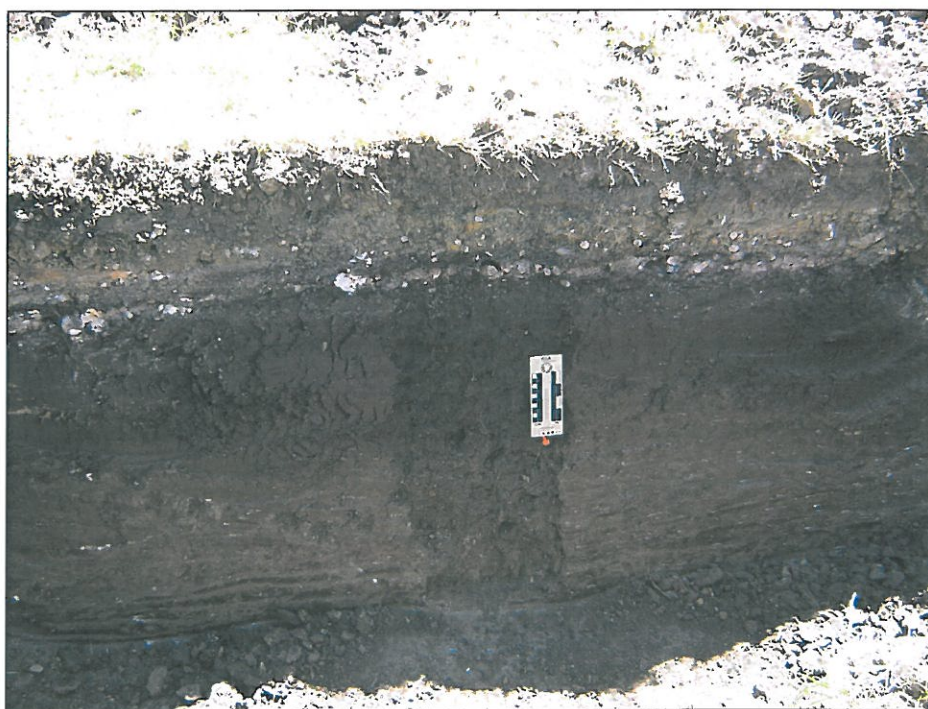
Figure 7. East wall of BHT 2.
